**Re: Romano vs. Chili's, et al.**

As you requested, I have reviewed the initial file material your office provided me for the above referenced matter. In addition, I conducted an inspection of the site where Ms. Romano was injured when she tripped and fell in the parking lot at the Chili's Restaurant in Kahala Mall. I also had the opportunity to interview Ms. Romano, as well as her sister who witnessed the fall. Given this information, I then conducted a safety and risk management analysis of Ms. Romano's falling incident. The purpose of this letter is to summarize my preliminary findings.

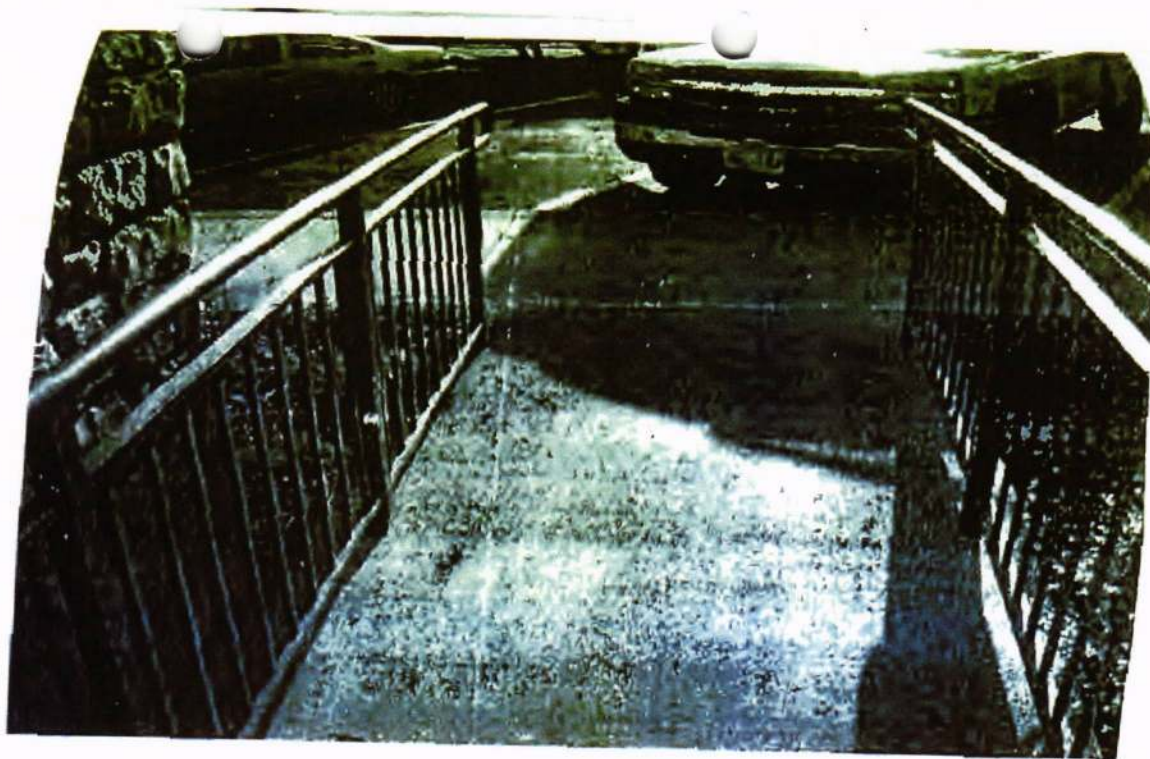
**Figure 1: Sidewalk/Ramp Approaching the Parking Lot Area**

Ms. Romano exited Chili's Restaurant and proceeded down the main sidewalk, which was a designated ADA handicap access ramp towards the parking lot (See Figure 1). Upon reaching the end of the sidewalk, Ms. Romano stepped off the curb and onto the asphalt parking lot surface below. However, unbeknownst to Ms. Romano, the asphalt surface was not planar; rather there was an overlay on the asphalt that did not continue flush all the way to the curb; as a result there was an elevated "seam" in the asphalt that ran parallel to the concrete sidewalk and curb (See Figure 2).

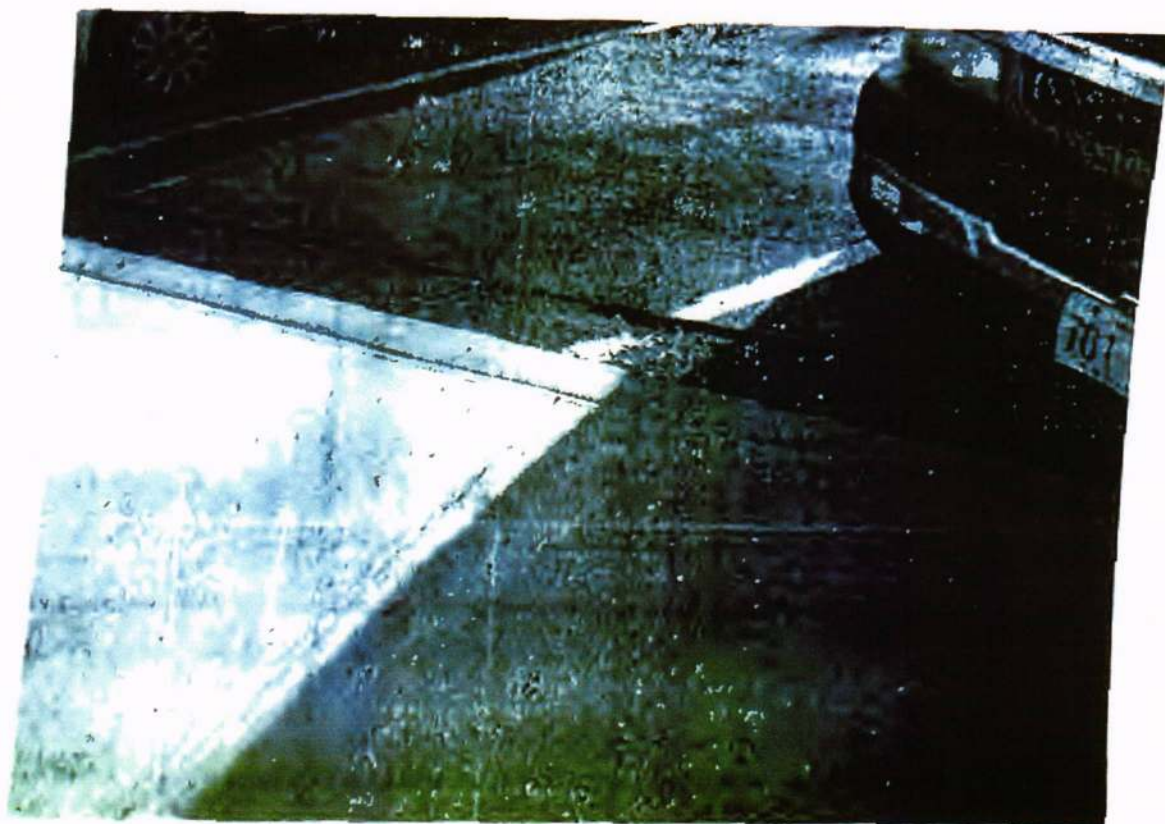
**Figure 2: Close-up View of Area Where Ms. Romano Stepped Down onto the Parking Lot Surface**

The offending vertical lip in the parking lot that induced Ms. Romano's fall, which I measured to be ¾ of an inch high, is depicted in Figures 2 and 3. These photographs show that the parking lot area where Ms. Romano fell was **broken, depressed, uneven, and cracked with pieces missing**, thereby creating an **abrupt variation in elevation between surfaces**, inducing Ms. Romano's loss of balance and eventual fall. It is unequivocal that this defective condition in the parking lot, which induced Ms. Romano's fall, was in direct violation of the minimum safety requirements of ASTM F-1637-95 and created an unreasonably dangerous risk of harm to pedestrians such as Ms. Romano.

It is my understanding that Ms. Romano's trip and fall occurred at night. It is noted that there are no parking lot lights in the immediate area of Ms. Romano's trip and fall. As such, it would have been even more difficult for Ms. Romano to have detected the unexpected trip hazard created by the elevated seam seen in Figure 2, particularly given the low contrast between the upper and lower surfaces.

*It should be noted that the offending vertical lip was not something that "occurred over night"; rather, it appears that it was a defect in the asphalt paving. That is, as seen in Figures 2 and 3, the vertical lip in the asphalt appears to be created by an overlay on the asphalt surface that simply did not continue the last 12 inches or so up to the face of the concrete curb. In other words, the vertical lip appears to have been in existence since the time the asphalt surface was initially overlaid. In short, the Defendants knew or should have known of this defective condition well before Ms. Romano's fall.*

*The most effective plan would have focused on the root cause of the hazard, namely the dangerous vertical lip in the asphalt parking lot, which was located in an area where people would expectedly walk/step. As discussed above, this condition that was located in the space immediately alongside the sidewalk, in an area where people stepping from the sidewalk onto the parking lot surface would foreseeably step; created an unexpected (for the pedestrian) and hidden hazard that was unreasonably dangerous. This hazardous condition could have and should have been corrected vis-à-vis Safety by Design, by simply filling in/continuing the planar asphalt overlay until it abutted the concrete curb. The failure to have done so was a violation of the Fundamental Principle of Safety.*

*Alternatively, Guarding could have and should have been employed as an interim measure until the defective parking lot tarmac could be properly repaired. For example, saw horses and/or traffic cones could have been used to close off the subject parking stall(s) until proper repairs could be made. The failure of the Defendants to have done so was yet another violation of the Fundamental Principle of Safety.*

*At the very least, the Defendants could have and should have implemented Persuasion Control (i.e. such as marking the edge of the offending vertical lip with bright yellow safety paint) until the defective/dangerous condition could be properly repaired. The failure of the Defendants to have done so was an additional violation of the Fundamental Principle of Safety.*
